# SERVICE REPRESENTATIVE'S REPORT

PRATT AND WHITNEY AIRCRAFT  
EAST HARTFORD 8, CONNECTICUT

### 1. Preparation of COIN for Flight.

## 1. Convair COIN Incident

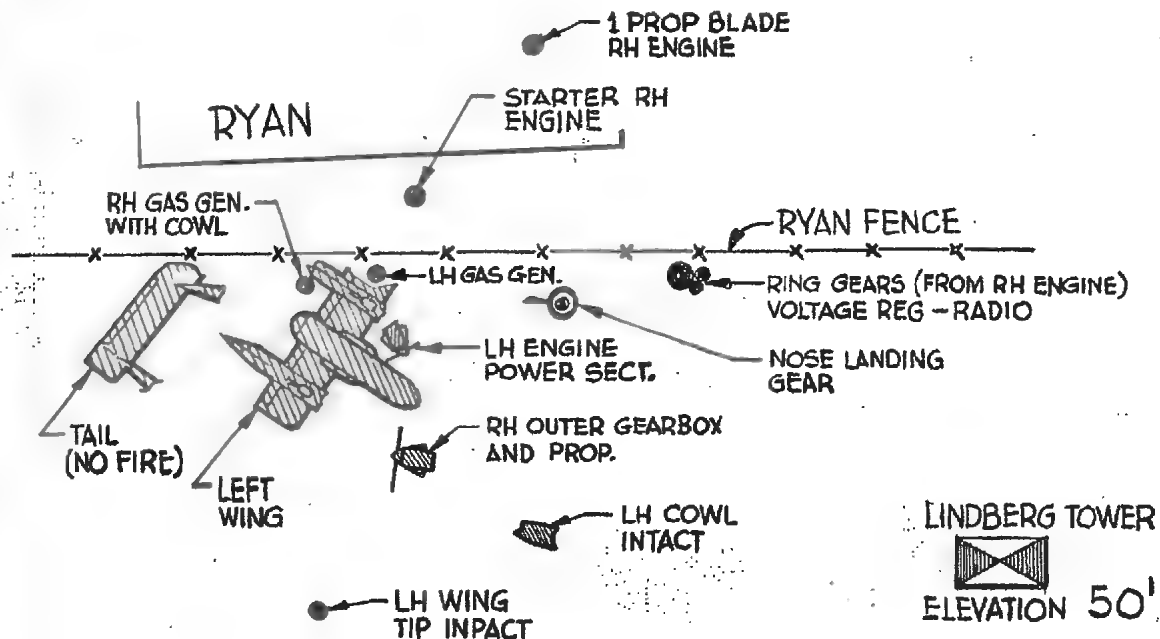
The photographs and sketch generally describe the crash area as to location of the debris. The left engine(feathered on impact)broke free from its nacelle and was found in front of the right nacelle. The power section separated completely, and intact, from the gas generator and was found adjacent to the latter. The propellor hub was intact and attached to the prop shaft. The prop blades were feathered. The prop hub was found in relatively good shape.

The right engine gas generator remained generally in its nacelle. The outer reduction gearbox separated at the mounting flange and came to rest forward of the left nacelle area. The first stage reduction ring gears and torquemeter gearing were thrown into the area where the aircraft nose ballast and equipment were found. The propellor hub was intact and attached to the prop shaft. One blade remained in the hub and was in fine pitch. Of the other two blades, one was found in the wreckage and the other landed on the roof of part of the Ryan plant some 100 yards distant.
